Manhole Inspection Summary

Manhole # S61I__008MH

Insp Date: **6/23/08 1:56 PM**

Location Address: **600 Savage St.**

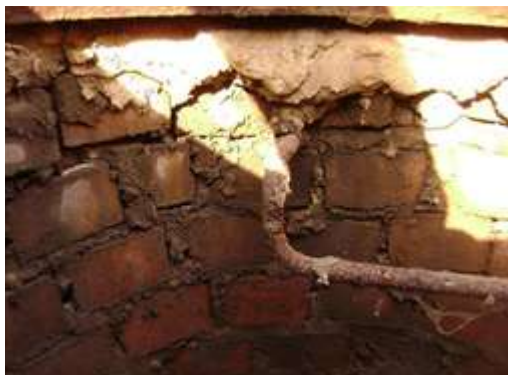
Defect 1

Infiltration: ☐ None ☒ **Joint** ☐ Cracks ☒ **Mortar** ☐ Roots ☐ Wall

Cracks in mortar in chimney

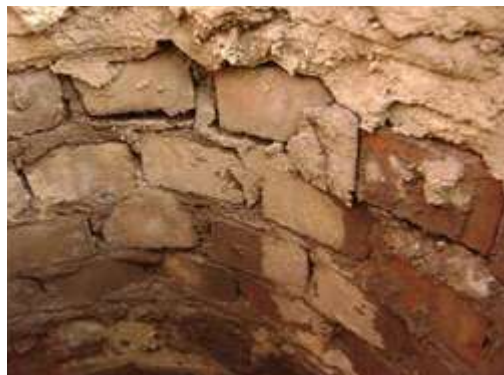
Defect 2

Condition: ☐ Sound ☐ Cracked ☐ Root Intrusion ☒ **Loose Brick** ☐ Deteriorated

Deterioration in the chimney and loose bricks.

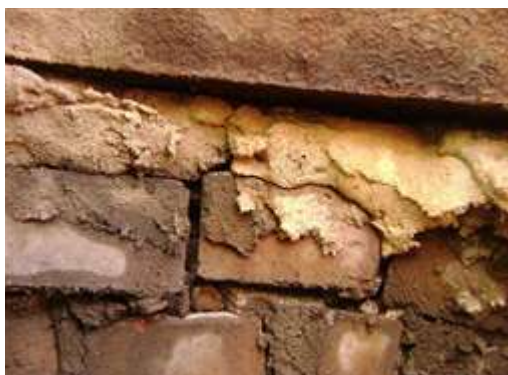
Defect 3

infiltration under the frame seal

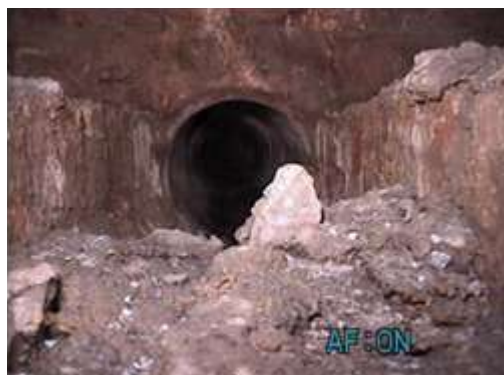
Defect 5

Heavy debris in channel

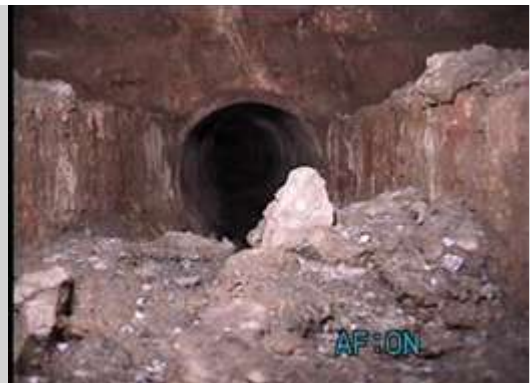
12 O'Clock Outflow

8 in. Circular Gravity Sewer
Pipe Out @ 12 O'Clock

Infiltration: **None** Pipe Seal Cond: **Sound**
